## **MICROSTRUCTURAL EXAMINATION OF V-4CR-4TI PRESSURIZED THERMAL CREEP TUBES - D. S. Gelles (Pacific Northwest National Laboratory)\***

### **SUMMARY**

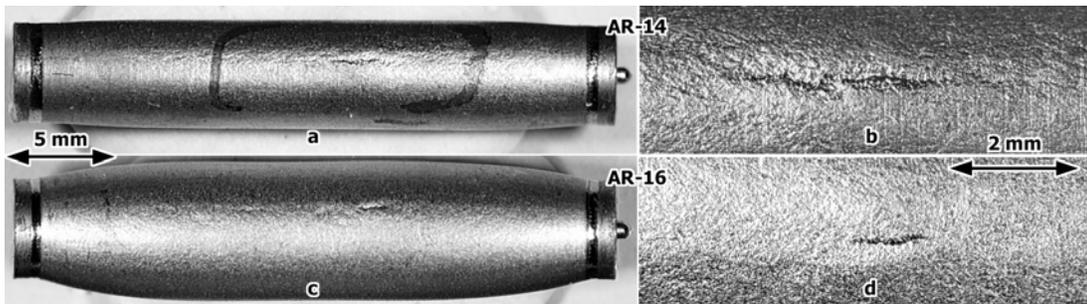
Photographs of tubes AR14 and AR16 using OM are shown in Figures 1a) and b), and c) and d), respectively. The tubes have been oriented to show the likely failure sites in the center of the tube. Tubes are 27.4 mm in length. In both cases failure appears to be due to formation of a longitudinal crack but the crack is shorter following testing at the higher temperature.

Figure 1. Failed pressurized tubes AR14 in a) and b) and AR16 in c) and d) shown with the likely failure sites face-on at low and intermediated magnifications.

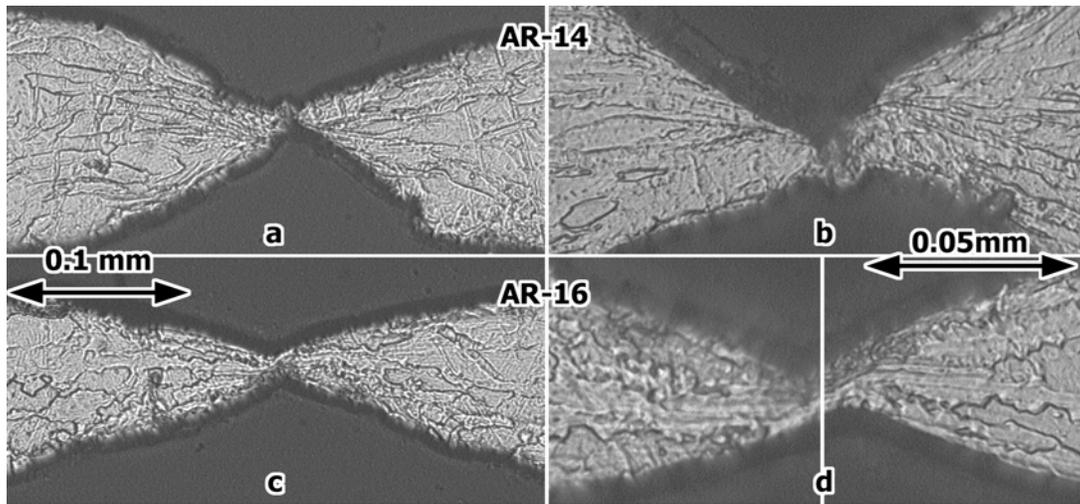
Metallographic sections were then prepared in order to locate through-thickness cracks. Examples are provided in Figure 2 showing regions in specimens AR14 and AR16 that contain areas that have been reduced in wall thickness to the point of failure. From Figure 2, examples of grain elongation can be identified in each of the thinned sections, indicating that strain within grains reached high levels in comparison to grains in unthinned regions, where grains remained equiaxed, despite strains up to 50% as in specimen AR16. Therefore, local plasticity was very high prior to failure and failure was a result of that thinning.

Figure 2. Optical metallography examples of thinned sections of specimens AR14 and AR16.

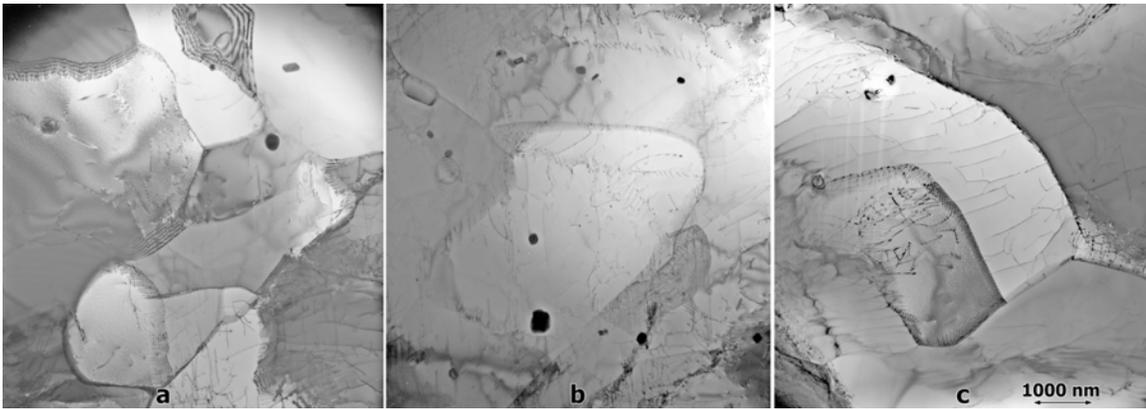
Figure 3. Examples of sub-grain boundaries in AR-16.

An estimate for  $K$  for V-4Cr-4Ti can be made based on the present work. For AR-16 at 800°C and 70.6 MPa, based on Figure 3,  $d_s$  is estimated at 1000nm. Then  $G$  can be estimated at 39.4 GPa based on [7], and  $b$  at 0.262 nm based on pure vanadium, allowing estimate of  $K$  at 6.8 if  $m = 1$ , or 735 if  $m = 0.26$ . The latter agreement with values for pure vanadium is perhaps remarkable.

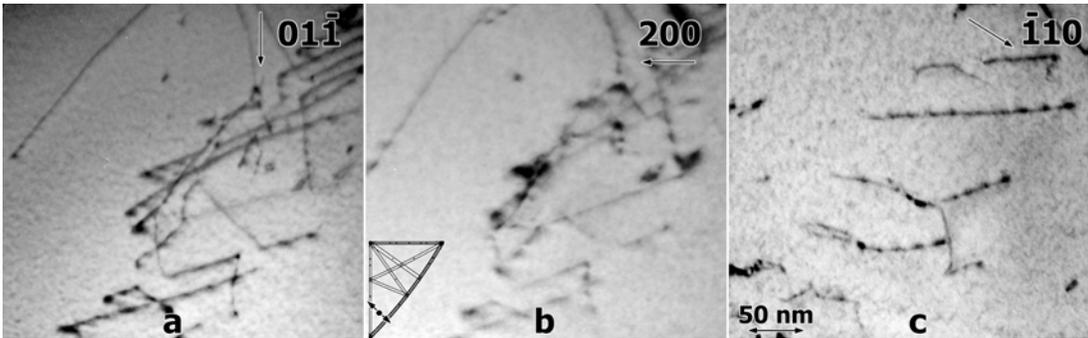
Applying this Burgers vector analysis to Figure 4 through 7 provides several useful observations. In both the a) and b) figures for each of these micrograph series, a fine array of dislocations can be seen on each sub-boundary, having Burgers vector  $\frac{a}{2}[\bar{1}11]$  in Figures 4, 6 and 7 and  $\frac{a}{2}[\bar{1}\bar{1}\bar{1}]$  in Figure 5. But the closely spaced dislocations in Figure 4 (at the upper right) are oriented differently than those in Figures 6 and 7. A second array of more coarsely spaced dislocations appears in all images of Figures 6 and 7 indicating a Burgers vector of  $\frac{a}{2}[\bar{1}\bar{1}\bar{1}]$ . Some dislocations appear curved in Figure 7, showing that the screw versus edge component may be changing for a single dislocation in a sub-grain boundary. This change in character is probably associated

Figure 4. A sub-grain boundary in specimen AR-14 at 700°C and 152 MPa.

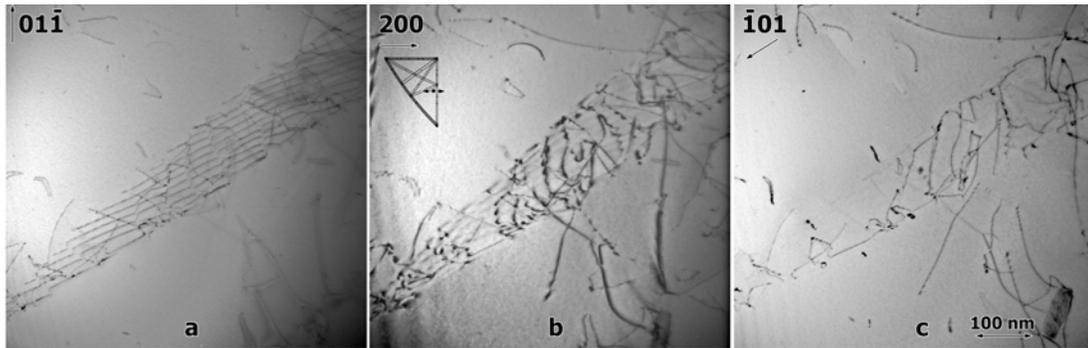
Figure 5. A sub-grain boundary region in specimen AR-16.

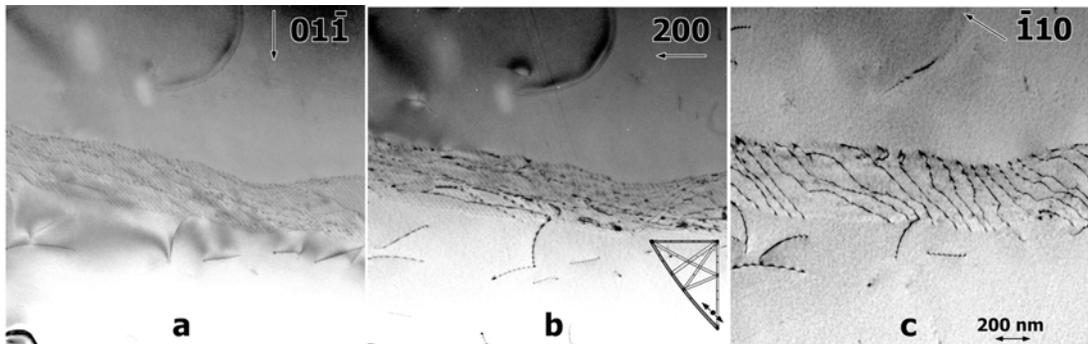
Figure 6. A sub-grain boundary in condition AR-16 at 800°C and 77 MPa.

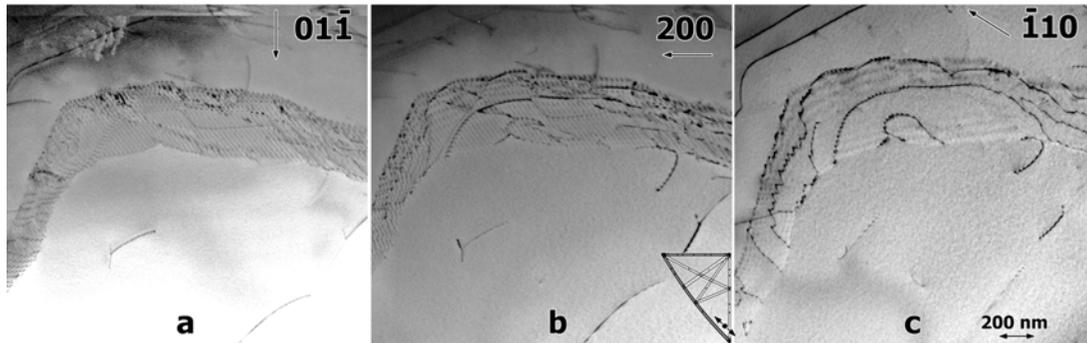
Figure 7. An adjacent sub-grain boundary in condition AR-16 at 800°C and 77 MPa.
