# MATERIALS ISSUES IN BUBBLING PFBC SYSTEMS

I. G. Wright<sup>1</sup>, J. Stringer<sup>2</sup>, and J. M. Wheeldon<sup>3</sup>

## ABSTRACT

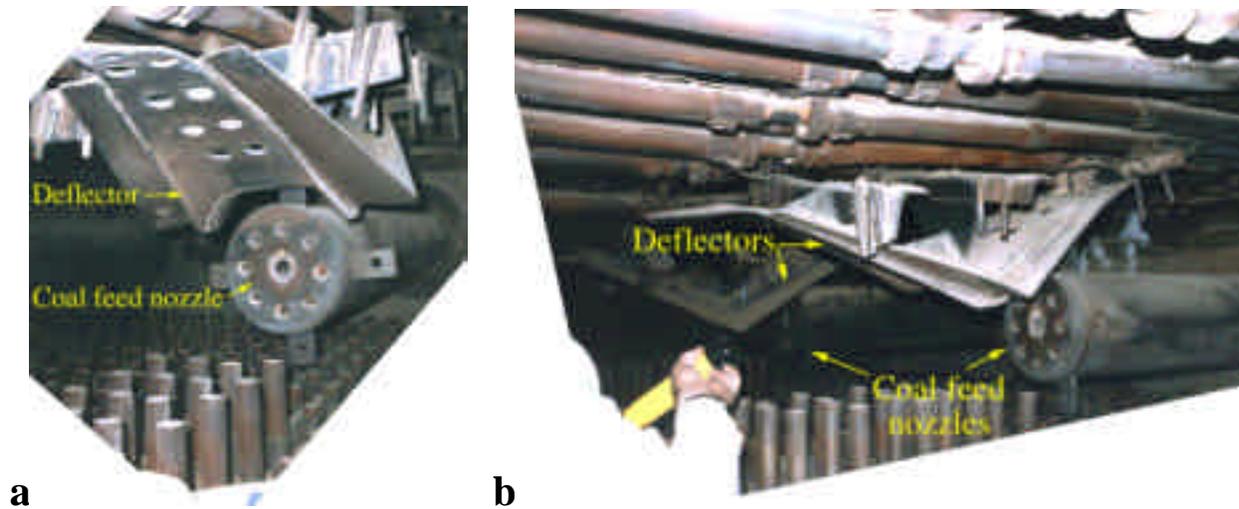
In the early stages of operation at both Värtan and Tidd, problems were experienced due to overbed combustion, which appeared to have been related to gas channeling in the bed. Plumes of volatiles together with unburned carbon particles were carried into the freeboard and to the cyclone inlets where they combusted, generating excessively high temperatures in those locations. Channeling of the gas flow also resulted in burning volatiles and carbon particles being directed preferentially into specific cyclones. One consequence of these high temperatures may have been the cracking of the ceramic liners in the ash removal legs (discussed later), as well as sintering of fly ash collected in the cyclones. These post-bed combustion problems were traced to very localized release of coal volatiles and fine char near the fuel discharge nozzles. As a measure to disperse these plumes, V-shaped deflectors ('skateboards') were installed above the fuel nozzles to better distribute the entering coal slurry, as shown in Fig. 2. Installation of additional air distribution nozzles to increase the local fluidizing velocity in front of the coal nozzle further enhanced dispersion. These nozzles were also lengthened to limit the potential for the coal slurry to move downwards and adhere to the floor of the combustor.

Figure 2. A 'skateboard' deflector above a coal feed nozzle at Tidd, and the added air nozzles.

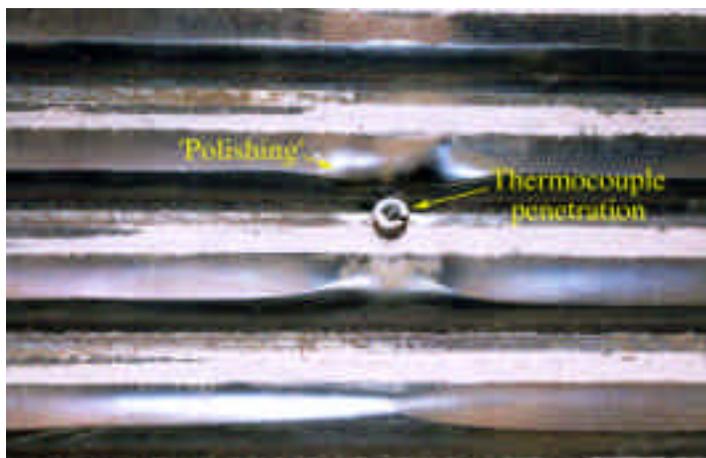
Thinning of all four walls of the boiler at Tidd was observed in a region 1.5 m above the air distribution sparger ducts and 1 m below the top of the tube bundle. When the in-bed tube bank was partially removed following the final shut down, areas of the membrane wall such as those shown in Fig. 3 were found. Here, instead of being curved, the tube surfaces had been rubbed flat by what is understood to be the downward motion of the bed material at the wall. In the example shown, the wastage appeared to be influenced also by a local flow turbulence associated with a thermocouple penetration in the wall. By comparison, the Escatròn plant showed very little membrane wall wastage, presumably because the bed material was not very erosive. Nevertheless, based on the Värtan experience, wastage-resistant coatings were applied at the manufacturing stage to the membrane walls in the fourth P-200 plant at Wakamatsu.

Figure 3. 'Polishing' of the waterwall at Tidd in the vicinity of a thermocouple penetration.

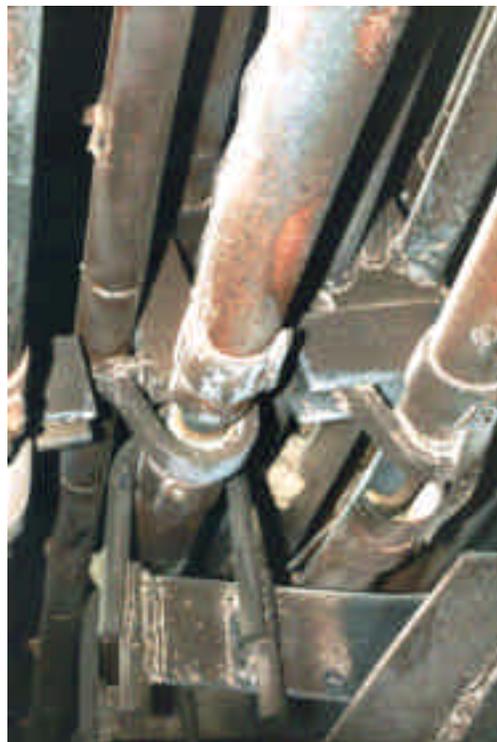
Figure 4. Shielding installed to protect the superheater tubes (bottom row) in the tube bundle at Tidd

negligible wastage, although some very localized wastage was observed in the 1995 inspection, and led to the application of sleeves to those areas. Inspection in the summer of 1996 indicated no additional wastage on the unprotected parts of the superheater tubing.

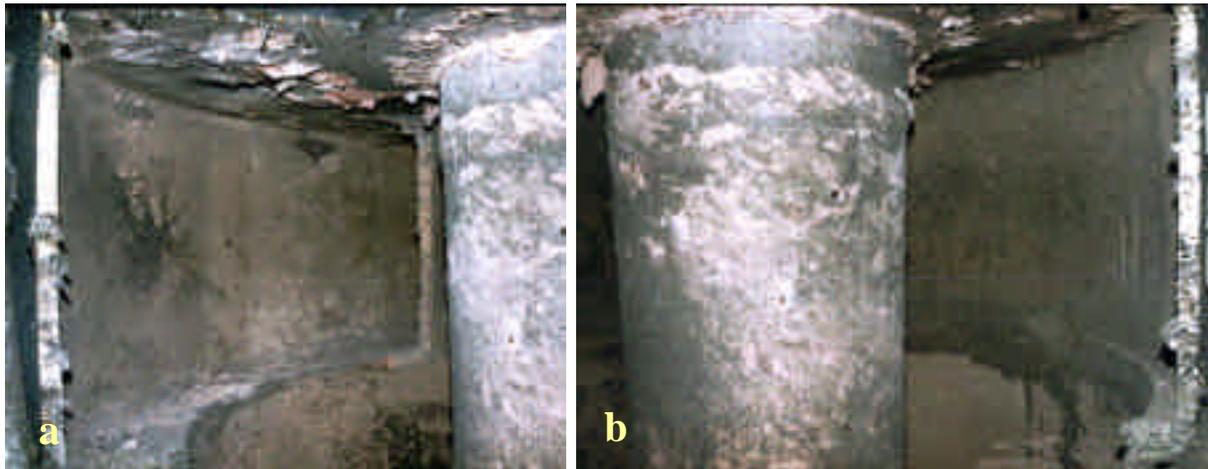
Figure 5 shows the remaining ash deposits on the inside surfaces of a primary cyclone at Tidd after final shut down. The section through which this view was taken had been removed to check for erosion damage.

Figure 5. Inside view of a primary cyclone at Tidd showing residual dust deposits.

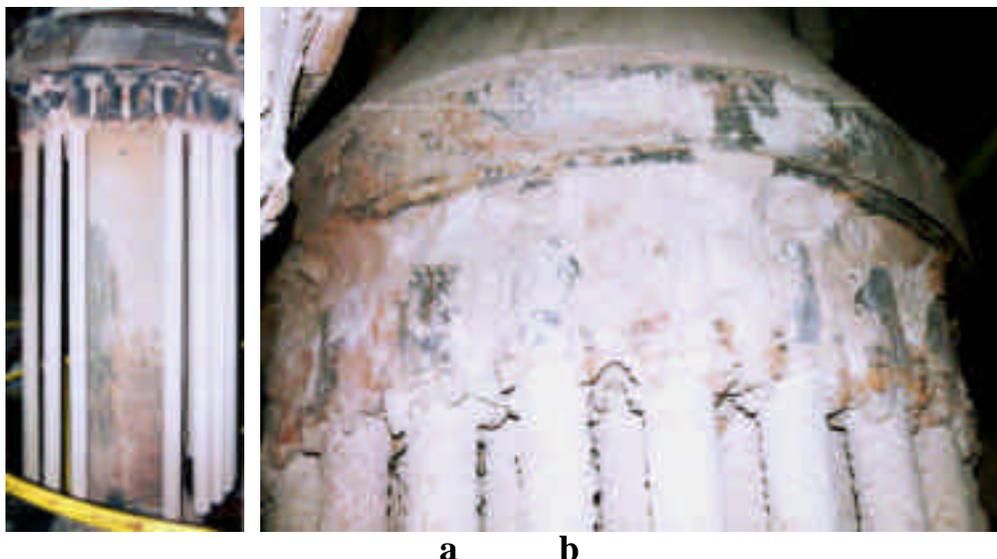
Figure 8a shows the appearance of a cluster of candles in the upper grouping following final shutdown. The inner ring of candles had been removed as part of the measures to avoid ash bridging. Three of the remaining candles were missing, and had probably been removed for post-test evaluation. The build-up of ash deposits on the non-porous regions at the top of the candles is shown in Fig. 8b. It is in this location that bridging was thought to initiate. Figure 9 illustrates the state of the candle filter surfaces after final shut down. No bridging was observed. Note the variation in appearance of the outer surfaces of the remaining filter cake on the sets of different types of candles.

Figure 8. Overall view of the upper candle arrangement in the APFF at Tidd. In a) three candles have been removed for post-test evaluation; (b) heavy ash deposition above the porous regions of the candles

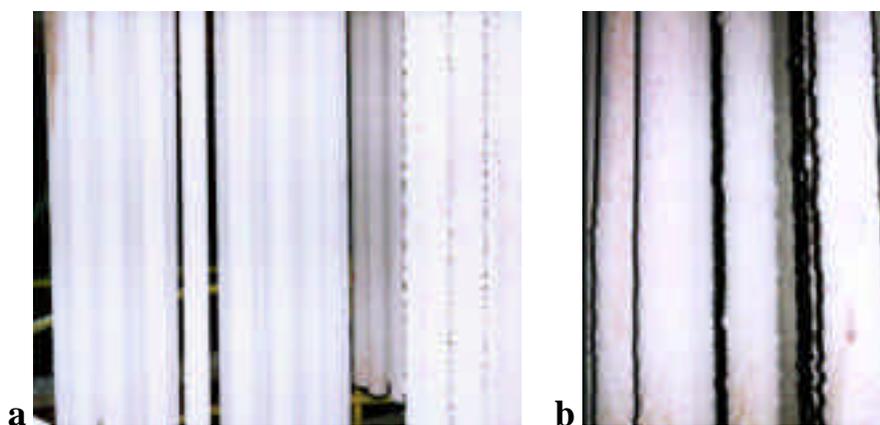
Figure 9. Appearance of the filter candles in the Tidd APFF after final shutdown. Note the different appearance of the filter cake on different sets of candles.

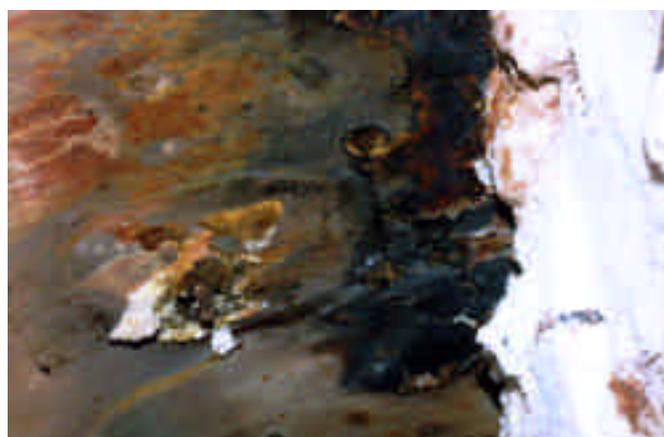
Inspection of the head of the APFF pressure vessel following the final shut-down of the Tidd plant revealed damage due to aqueous (condensate) corrosion beneath the insulating material that been used to line the vessel (Fig. 10). It was thought that the insulating material was wetted by condensation, keeping the metal in a permanent acidic environment. It was concluded that a refractory lining would be preferable for future applications. However, this does not totally eliminate the problem as SO<sub>3</sub> can still reach the inner metal surface through diffusion, or convection through cracks. To prevent this from being a problem, the metal surface also needs to be protected in some way. One way is to fuse an acid-resistant polymer to the metal prior to applying the refractory. Alternatively, the refractory could be designed such that the metal surface operated above the dew-point temperature.

Figure 10. Damage to the head of the APFF vessel at Tidd from aqueous corrosion

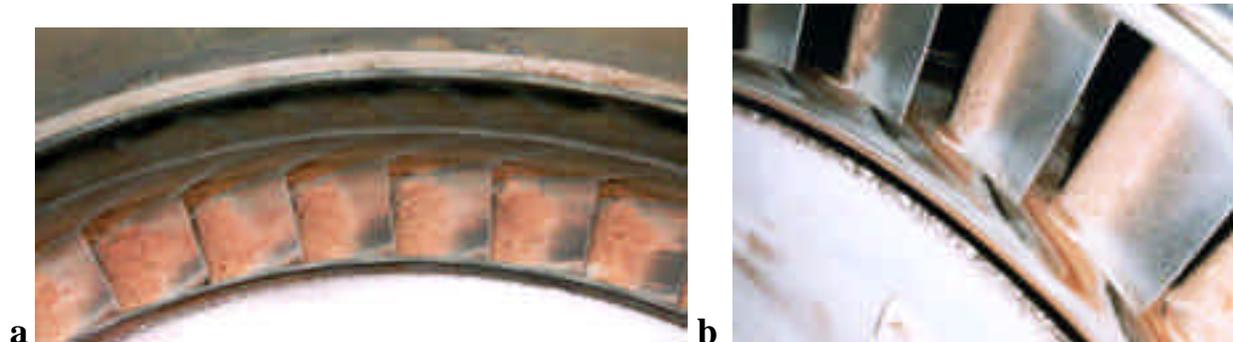
Figure 11. Inlet guide vanes to the high-pressure turbine blades, showing heavy deposits on the suction surfaces

Inspection of the gas turbine following the final shut down of Tidd found red-colored deposits on most of the hot gas path surfaces. Figure 11 shows some of these deposits on the Row 1 inlet guide vanes (heavier on the suction side than the high-pressure side). The tips of the Row 1 blades exhibited obvious erosion or wear damage, as shown in Fig. 12. One possible cause of such erosion is the formation of vortices at crevices, trailing edges, and other locations which cause flow disturbances that may entrain particles and cause localized erosion where the vortices impact on neighboring turbine components. Wear lines on the outer (Fig. 11a) and inner part (Fig. 11b) of the vane housing may support this supposition. Tip wear also may have been due to an increased dust loading at the casing due to centrifuging of the dust.

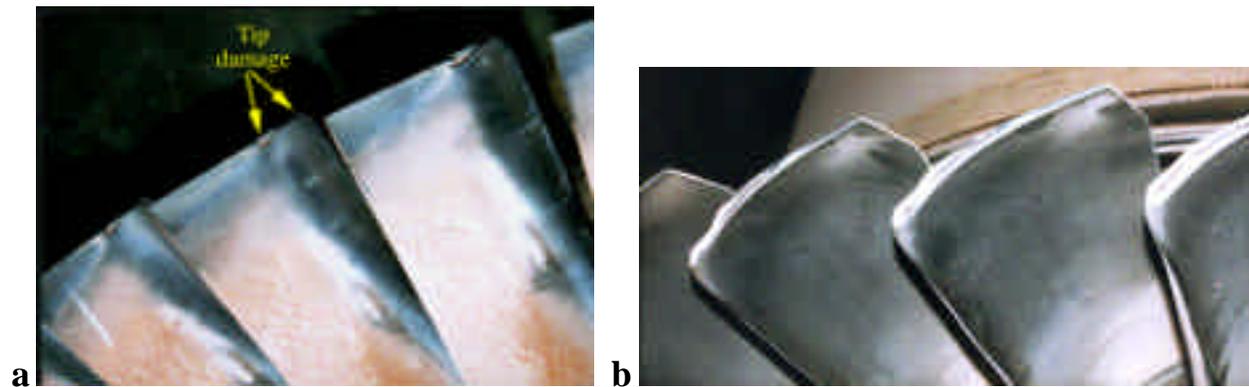
Figure 12. Erosion/wear damage to the high-pressure turbine blade tips (a) suction side of cooled (Row 1) blades with damage around the cooling air channel exits (b) deposit-free high-pressure side of HP blades

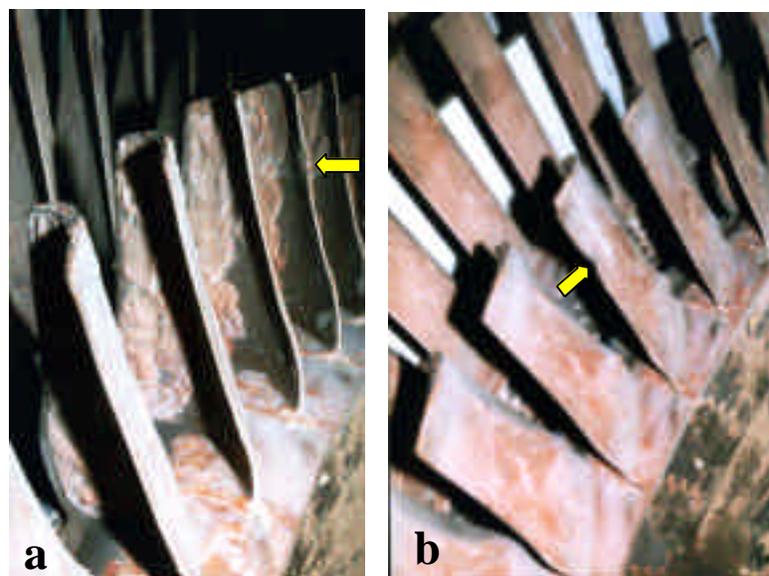
Figure 13 shows ash deposits on the pressure side of a row of uncooled, low-pressure turbine blades. If such heavy, tenacious deposits are typical of those present during operation, they would be expected to have affected shaft balance, possibly contributing to the vibration problems reported for this turbine. There were also signs of distortion and impact damage on these blades, more than would have been expected from 250-micron ash particles. This impact damage may be associated with an earlier compressor blade failure arising from vibration-induced stress.

Fig. 13. Uncooled low-pressure turbine blades showing (a) heavy deposits on the pressure surfaces (b) view of the suction side distortion as well as impact damage (arrows)

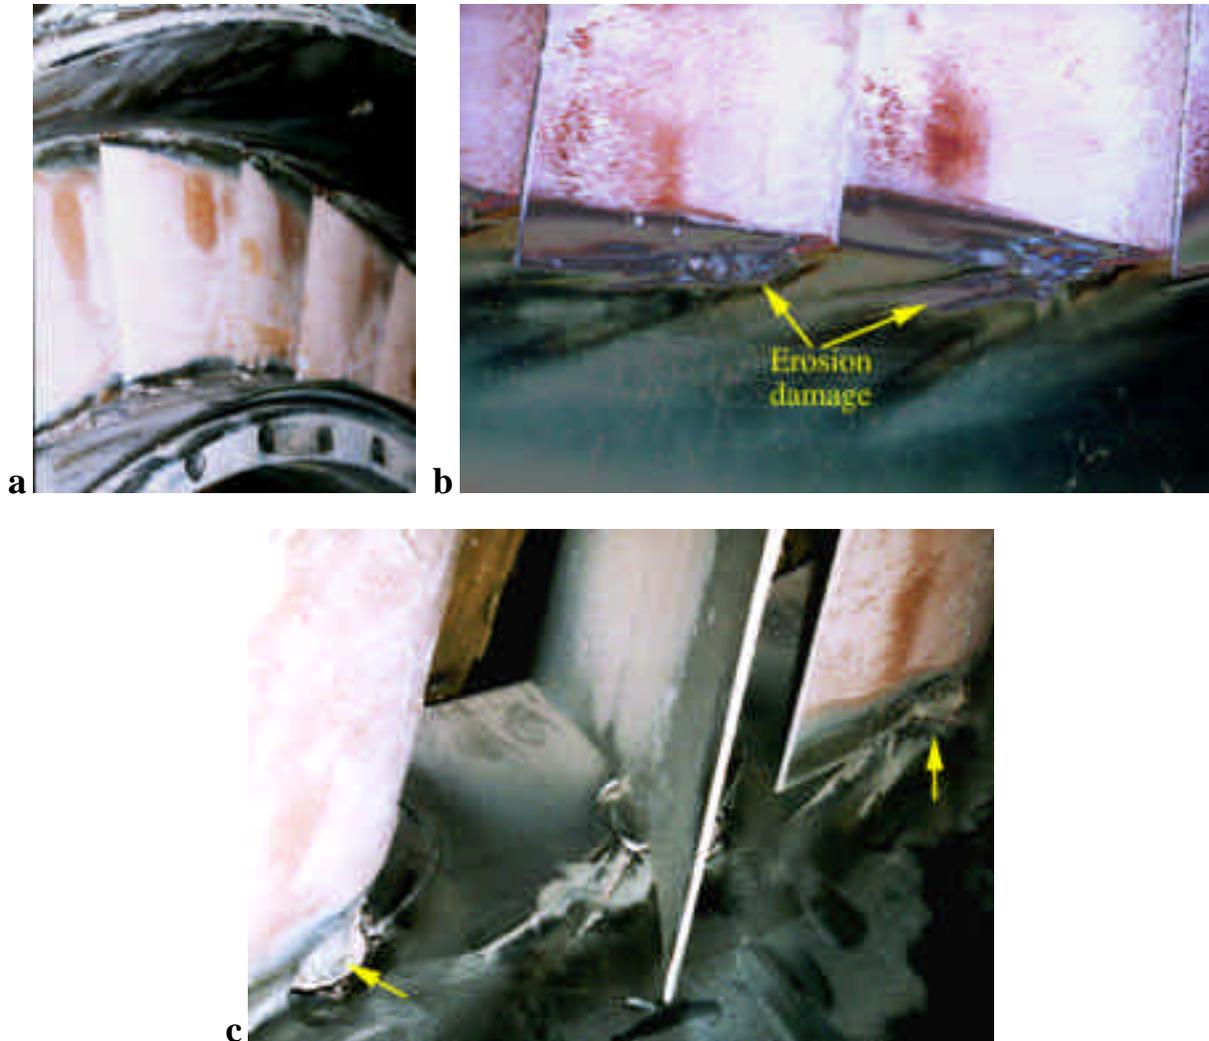
Figure 14 shows the variable inlet guide vanes to the low-pressure turbine. These carried heavy ash deposits on both pressure and suction surfaces, and also showed evidence of erosive wear on both the inner and outer surfaces of the vane housing. In particular, there appeared to be significant erosion in the region where the vane shafts penetrated the housing—possibly areas of flow disturbance.

Figure 14. Variable inlet guide vanes to the low-pressure turbine with (a) deposits on the suction surfaces; (b) and (c) erosion damage where the vane shafts penetrate the housing (arrows).
