# MATERIALS ISSUES IN BUBBLING PFBC SYSTEMS

I. G. Wright<sup>1</sup>, J. Stringer<sup>2</sup>, and J. M. Wheeldon<sup>3</sup>

## ABSTRACT

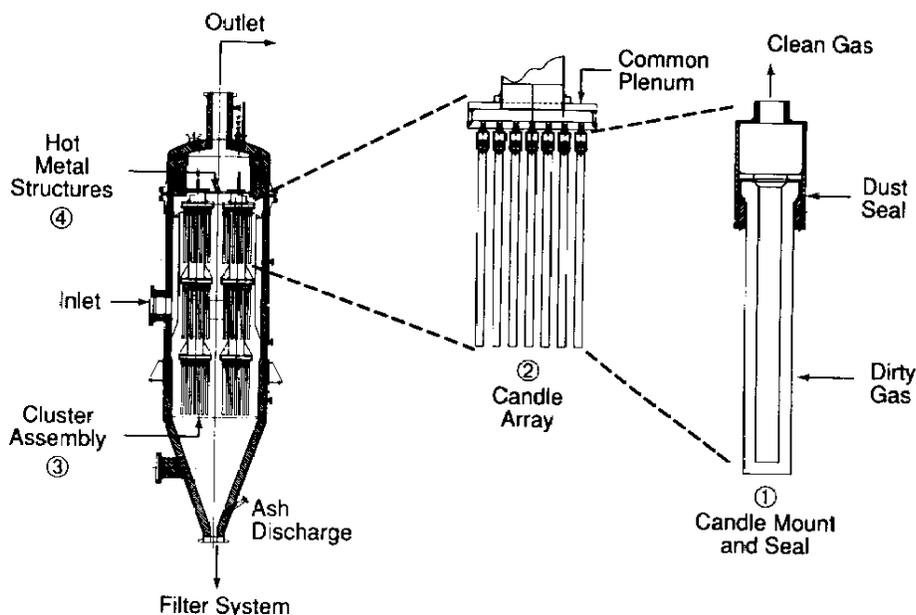
Figure 7. Details of the Advanced Particle Filter at Tidd (published by permission of AEP)

During initial operation, the relatively low inlet dust loading of fine fly ash particles transmitted from the primary cyclone proved to be very cohesive, particularly at temperatures above 760°C, and had a high tendency to agglomerate and sinter. This led to bridging between candles and difficulties in cleaning the candles and in draining the filter vessel. Besides reducing the effective filter area, the bridging resulted in the candles being ratcheted apart, eventually failing under tensile stress. Remedial measures were to remove 25 percent of the candles to create increased space between the candle elements and minimize the potential for bridging. This alleviated but did not eliminate the

problem. Next, the primary cyclone was detuned to pass more large particles to the filter to reduce the strength of the filter cake. This had some success and eventually it was decided to effectively remove the cyclone from service by blocking the ash discharge leg. This increased the inlet particle loading to the candles by a factor of 50 and the mass mean particle diameter by a factor of 10. Subsequent filter operation was stable with a solids outlet loading around 1 ppmw, but because of heat losses the filter operating temperature did not exceed 780°C.
