Electron Beam Cure Of Composite T-38 Windshield Frame/Arch

**Capt Jeffrey D. Farmer
Richard B. Warnock**

**USAF Advanced Composites Program Office
WL/MLS-OL
McClellan AFB, CA**

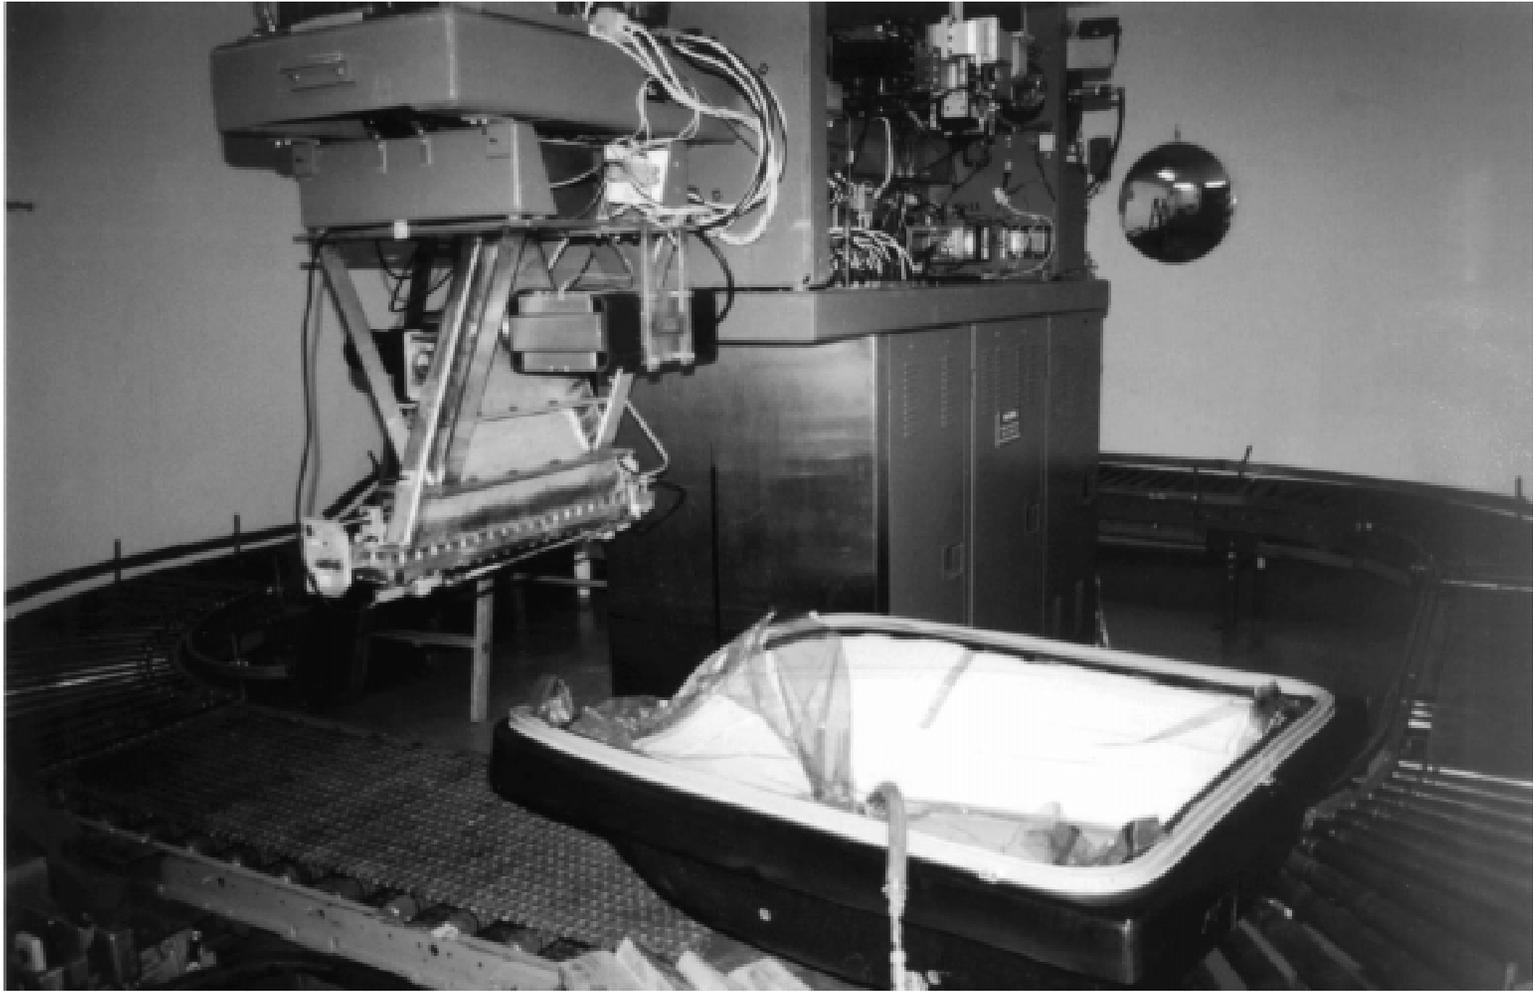
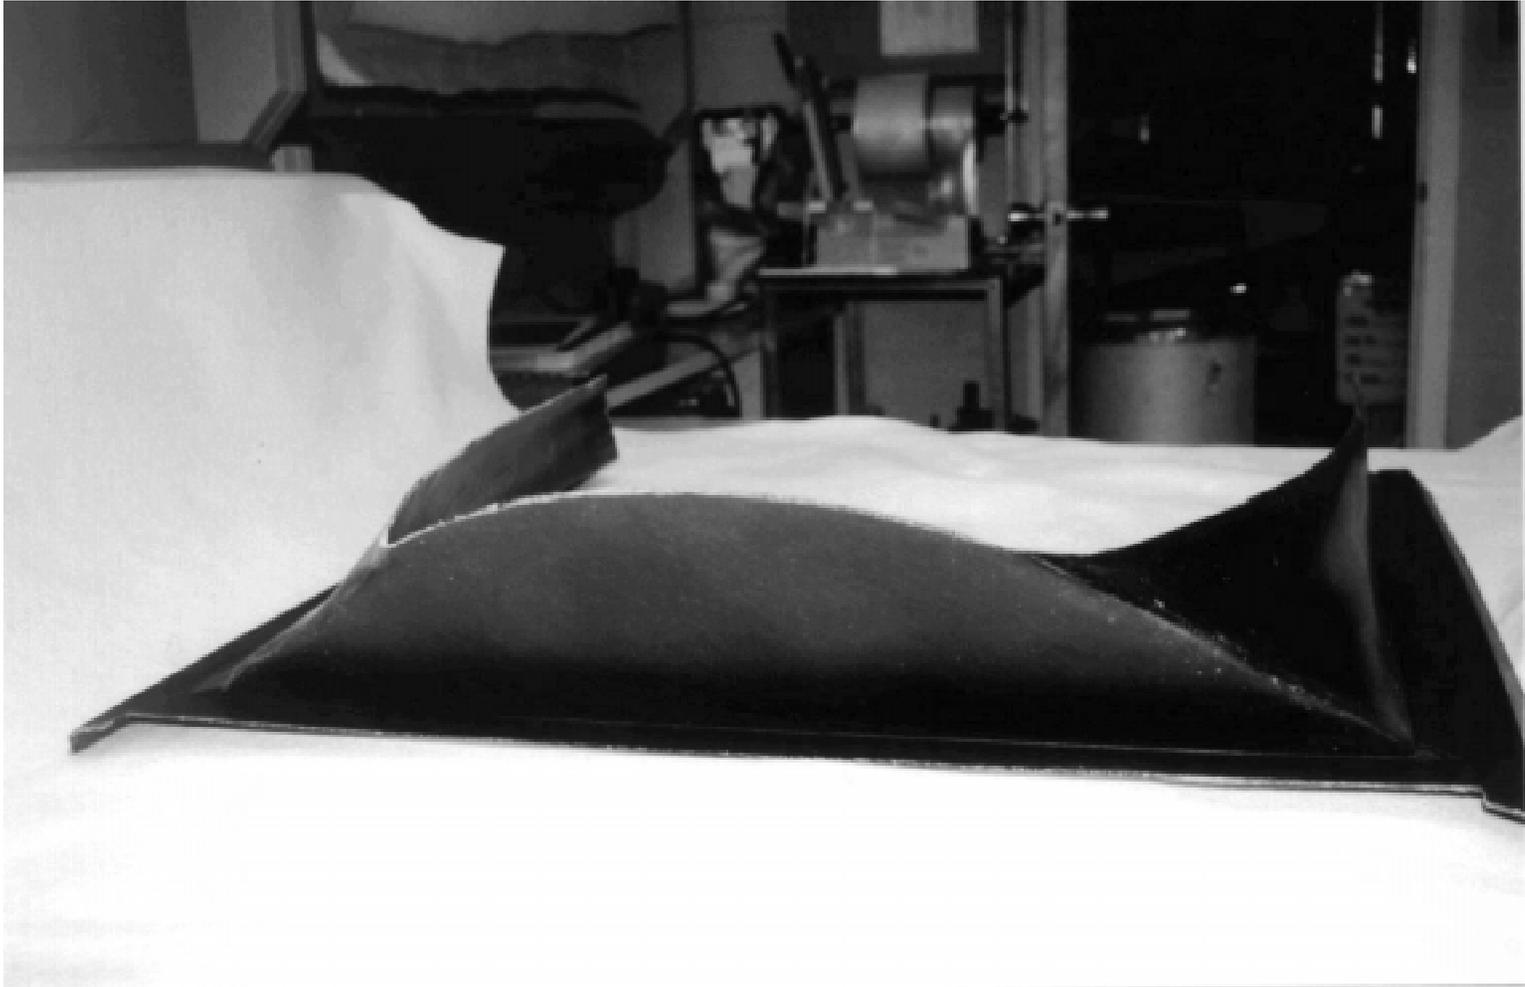
Manufacture of Innerskin, Bulkhead Doubler, Fairing

- **Structures Laid Up At AECL By USAF Mechanics**
- **Used Vacuum Only For Compaction Pressure**
- **Test Program Determined A Desired Dose Of 150 kGy**
- **1 kW E-Beam Facility**
- **Cure Times**
 - **Bulkhead: 1 Hr**
 - **Fairing: 2 Hrs**
 - **Innerskin: 3 Hrs**

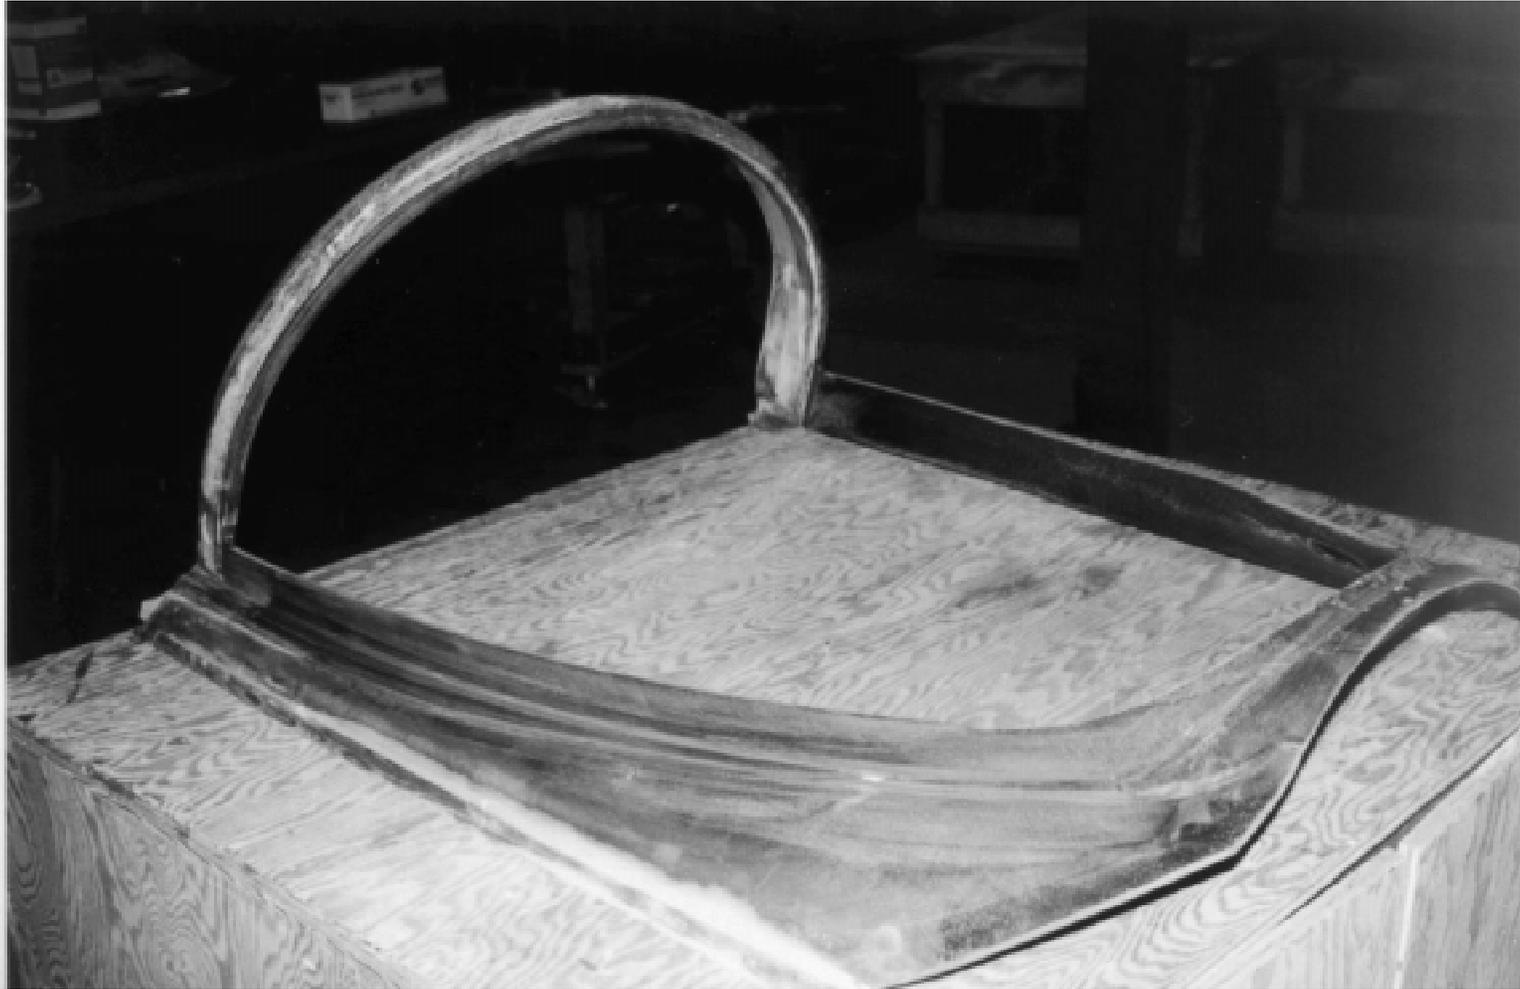
**Final Assembly Of The Components Took Place
At McClellan AFB Using Baseline Thermally-
Cured Epoxy**

- Not Considered Critical Since All Bondlines Have Fasteners To Attach Other Hardware**
- Note: Mechanics Noted That Structure Locally Delaminated When Fastener Holes Drilled**
